CALIFORNIA DEPARTMENT OF CONSERVATION DIVISION OF MINES AND GEOLOGY

THE 1983 COALINGA, CALIFORNIA EARTHQUAKES

SPECIAL PUBLICATION 66

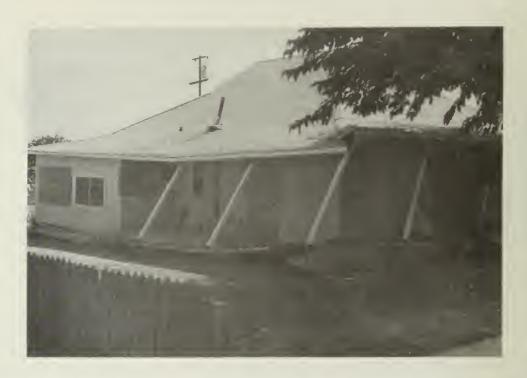
Plate 1 Displacement and extensive damage occurred when wood frame structures were inadequately secured to their foundations.

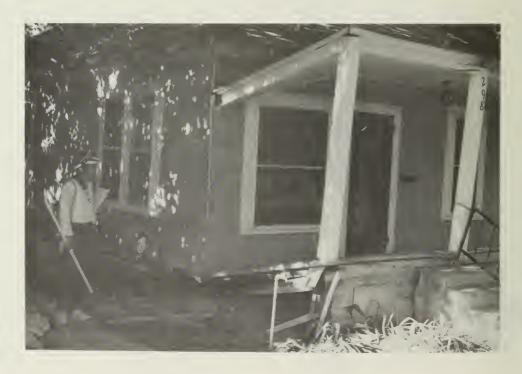
Plate 2 Displacement of wood frame structure accentuated by collapse of cripple posts.

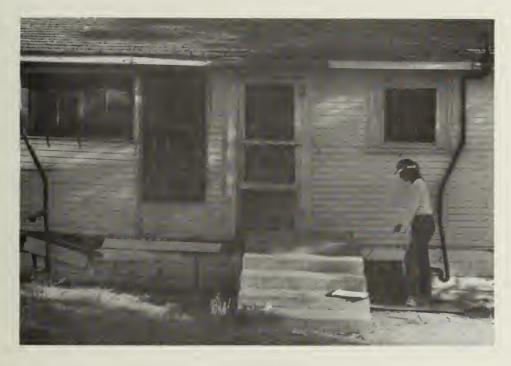
Plate 3 Lateral displacement of dwelling indicated by relative offset of structure from concrete steps.

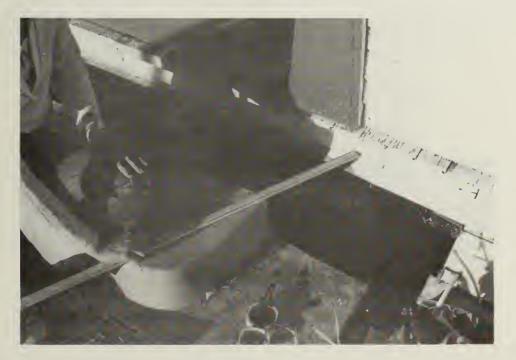
Plate 4 Magnitude and direction of offset indicated by displacement of corresponding structural elements.

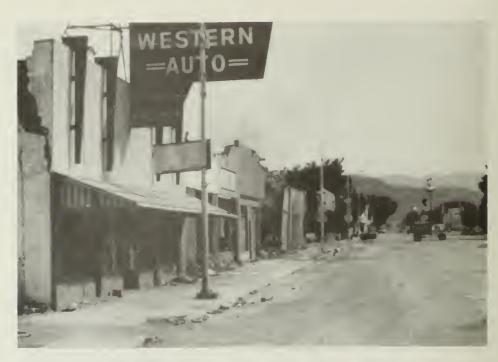
Figure 3. Fifth Street. Note damaged and fallen parapets, missing lamp, collapsed structure, center left.

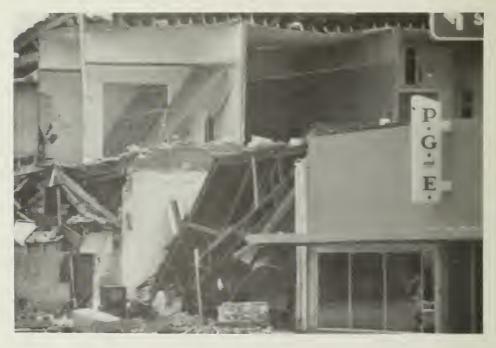
Figure 4. Close-up of damage on Fifth Street. Note ceiling joists at top of picture are being supported by the ceiling board.

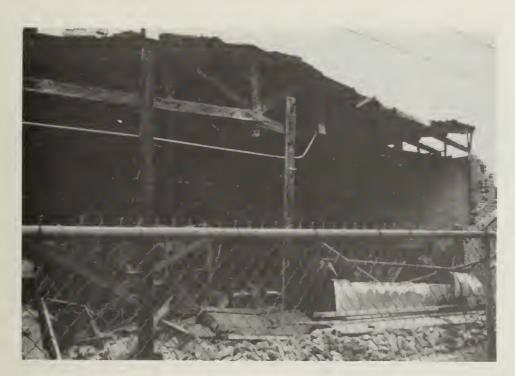
Figure 5. Commercial structures on Forest Avenue. Inadequate tying at the roof diaphragm of masonry walls parallel to the roof trusses resulted in the collapse of the walls.

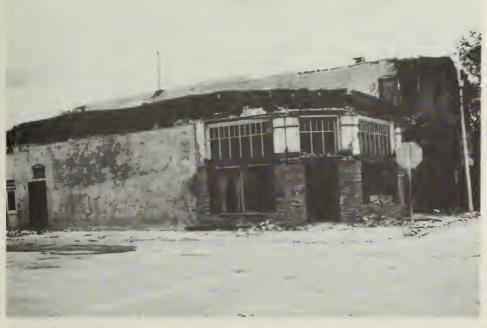
Figure 6. Forest Avenue. Note loss of masonry parapet, leaving roof joists unsupported.

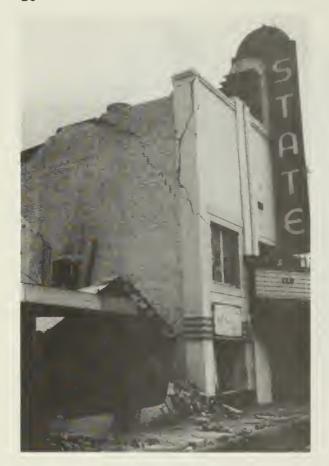
Figure 7. State Theatre. This much-publicized structure of unreinforced masonry construction suffered some of the most spectacular damage in the downtown area.

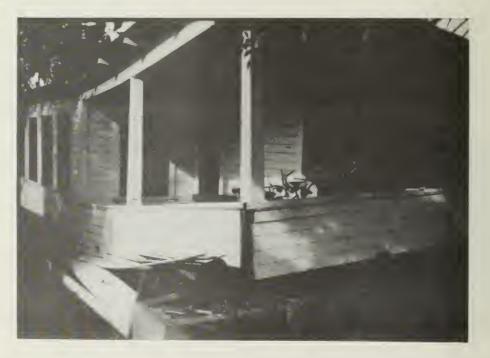
Figure 8. The most common cause of severe damage to residences in Coalinga was inadequate provision for shear transfer below the floor level. Shown here is a failure of the crawl space walls, which were clad with clapboard sheathing. Many of these homes were moved to Coalinga from the oil fields during the 1950s, and at that time were set on 18" cripple stud walls which were build on, but generally not anchored to, a concrete perimeter foundation.

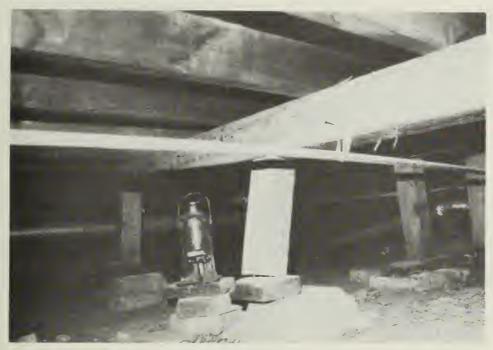
Figure 9. Jack post construction typical of the older wood houses in Coalinga.

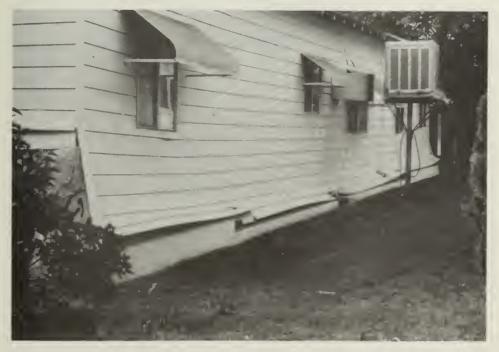
Figure 10. Another home which has moved off its foundation. Damage of this kind did not occur in homes where plywood replaced or covered the clapboard sheathing.

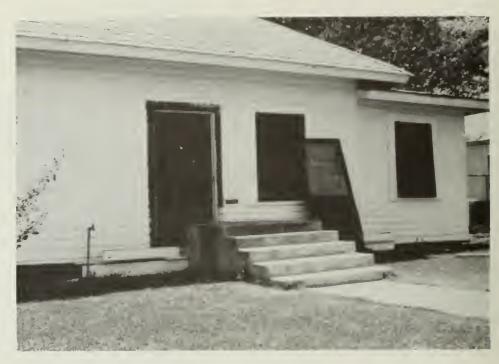
Figure 11. This otherwise undamaged residence has moved completely off of its cripple walls, as evidenced by the position of the porch steps.

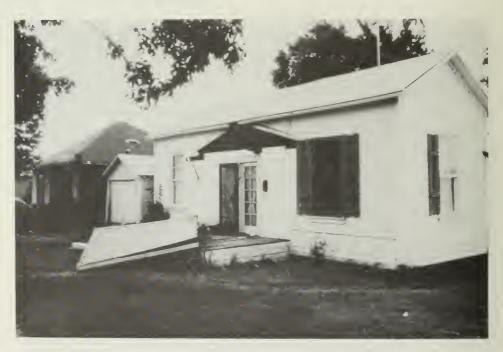
Figure 12. Collapse of wooden porch awnings demonstrates importance of proper anchorage and lateral support of such building appendages.

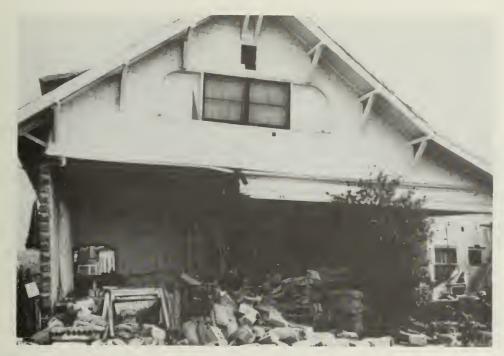
Figure 13. Unreinforced block masonry and poor anchorage of the walls to the diaphragms combined for disastrous results in this house on Monroe Street. A family of five escaped the wreckage unhurt.

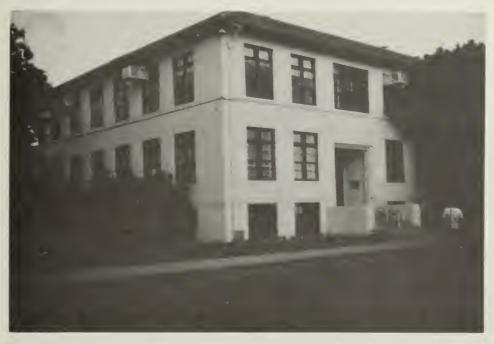
Buildings of reinforced concrete and reinforced masonry construction performed well, as shown in Figures 14 and 15. Some of these structures date from the 1930s and 1940s, when most design codes did not recognize the existence of seismic forces. Their exceptional performance may in part be attributed to large member sizes which arose from the less sophisticated design procedures available at that time, resulting in inherent strengths which are not generally accounted for. It should also be recognized, however, that the earthquake of May 2, 1983 apparently did not produce the intensity of shaking which is postulated for this area. An earthquake with similar maximum acceleration but of higher intensity and longer duration could well have produced more serious damage in many of the structures examined.

Figure 14. Coalinga High School. Heavy cast-in-place concrete construction. This building, with a date of 1930 cast over the door, suffered virtually no damage. The success of these buildings, designed with Codes which did not recognize earthquake forces, can be attributed to the inherent strength of cast-in-place concrete shear wall buildings and the attention of the Design Engineer to proper detailing.

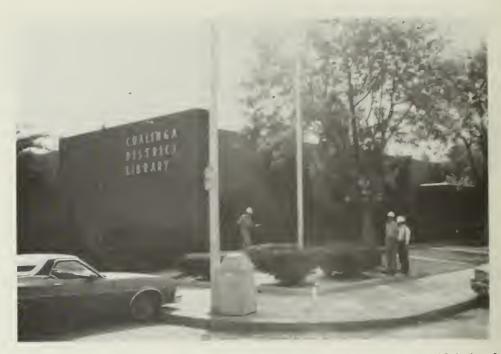
Figure 15. Public Library. Damage to this structure, build in 1955, was apparently limited to non-structural components - ceiling lighting fixtures dropped to the floor and books were displaced.

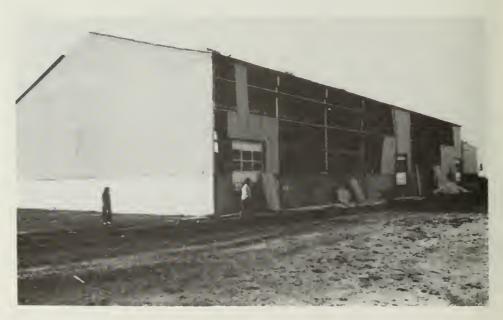
Figure 16. Light metal industrial building with transite panels on the south end of town. The lack of a longitudinal bracing system and the weight of the heavy transite panels resulted in substantial swaying of this structure and the subsequent loss of most of the panels on the longitudinal walls.

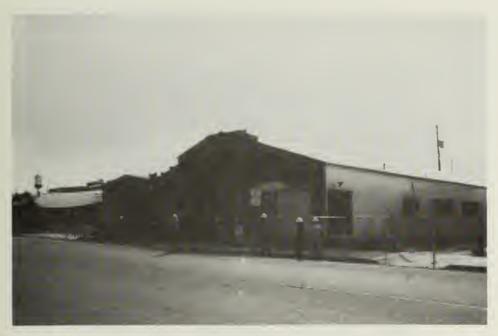
Figure 17. Light metal industrial building on Forest Avenue. When clad with sheathing, these structures generally performed well. This garage, however, was built against, but not anchored to a concrete wall on the left side. Several of the rod braces provided for lateral resistance along this wall were broken or buckled in the earthquake.

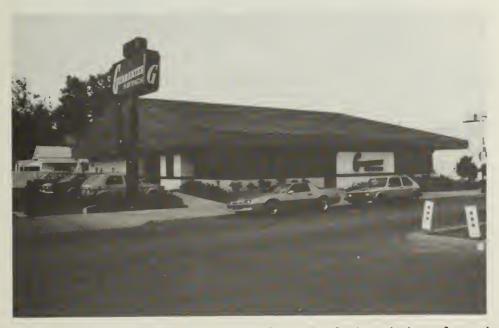
Figure 18. Guarantee Savings. Roughly 50% of the window glass in this building was shattered. Other damage was to ceiling panels and exterior plaster. Safe deposit boxes, stacked in the vault, overturned as well.

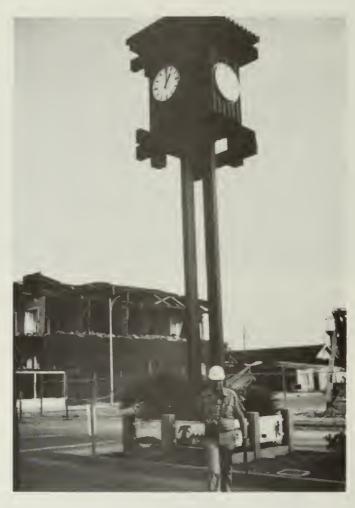
Figure 19. Clocktower, downtown Coalinga across from Guarantee Savings. This top-heavy structure was not adequately anchored against overturning. As a result, two of the four anchor bolts at the base broke, apparently in tension, leaving the tower free-standing on its concrete pedestal.

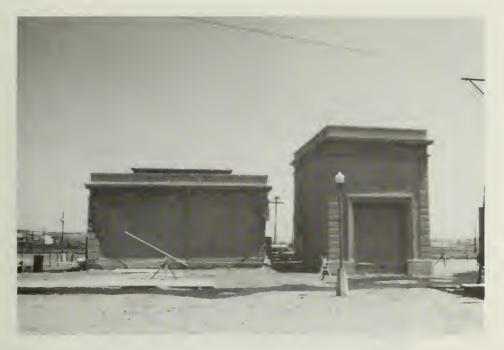
building attempted to resist the transverse lateral forces with frame action after the loss of the end walls. Figures 20 and 21 show these two structures, while Figure 22 depicts one of the large transformers at the substation.

Figure 20. The two buildings at PG&E Substation No. 2.

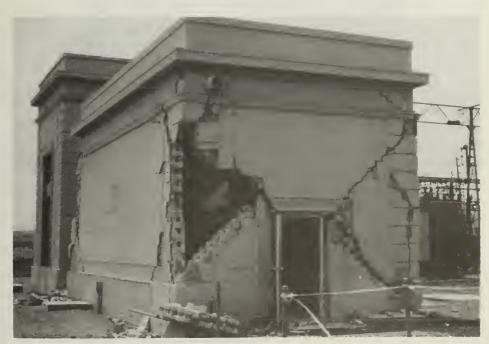
Figure 21. Major damage suffered by the unreintorced block building.

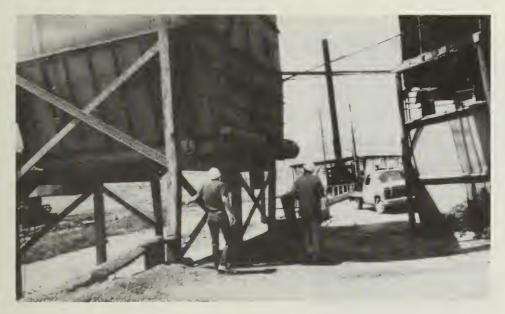
Figure 23. Coalinga Feed Lot. Home-built support structures for grain bins bent predictably about weak direction of columns where the X-bracing terminates.

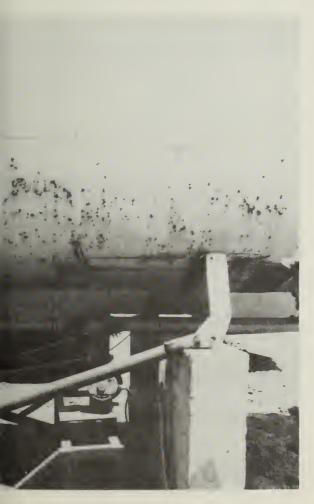
The Coalinga Feed Lot is a collection of small buildings and large equipment located approximately five miles west of the epicenter. The Feed Lot's small two-story reinforced masonry office structure suffered substantial damage during the main shock, as did many of the owner-built equipment support structures. Figures 23 and 24 show some of the damage which occurred at the Feed Lot.

Figure 24. Coalinga Feed Lot. This tank showed evidence of considerable sliding on its pedestal.

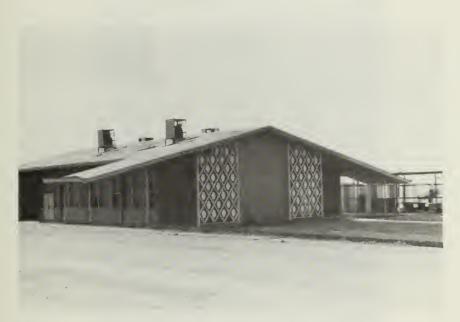
Photo 1. Oil King School-Intersection of Highway 33 and Highway 198

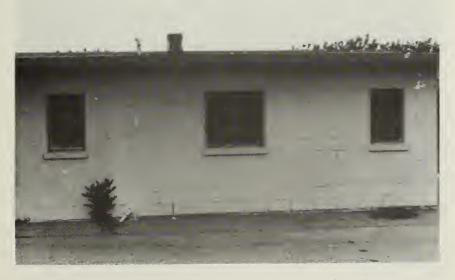
Photo 2. Cheney Kindergarten - Damaged Toilet Building

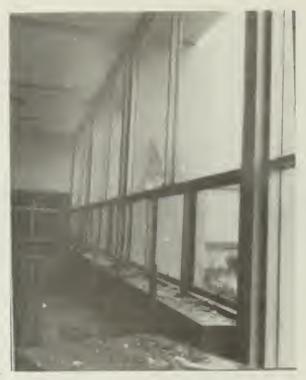
Photo 3. Coalinga Junior High School Library- Glass damage. (Photo by H. Heydt)

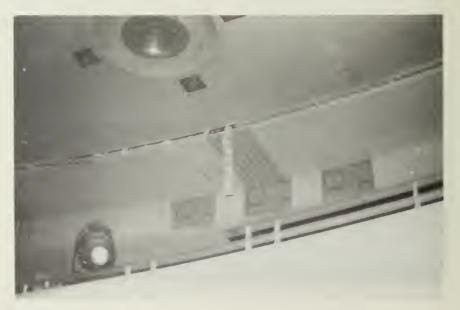
Photo 4. Coalinga High School Auditorium Ceiling damage

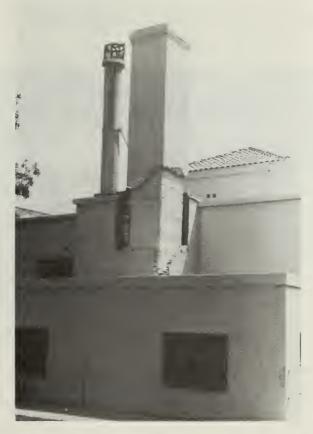
Photo 5. Coalinga High School Boiler
Room Damage. This building was
declared unsafe in 1937.

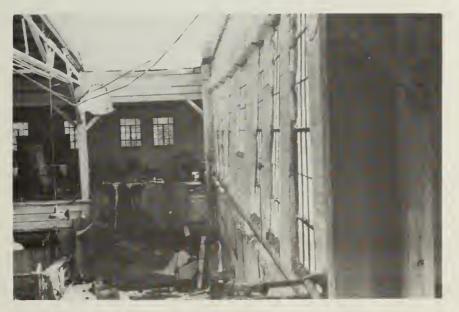
Photo 6. Coalinga High School Maintenance Building collapse. This building was declared unsafe in 1937.

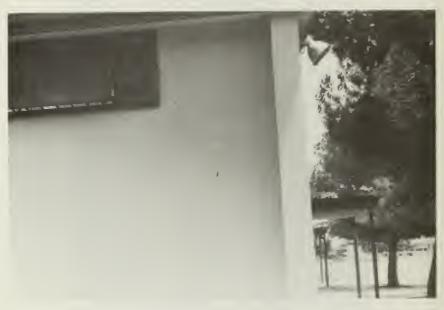
Photo 7. Coalinga High School Boys Gymnasium. Wall piers were cracked.

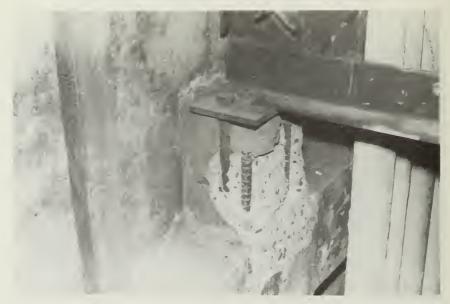
Photo 8. West Hills College Speach Arts Building.
The four horizontal ties around the steel roof truss anchor belts were omitted.

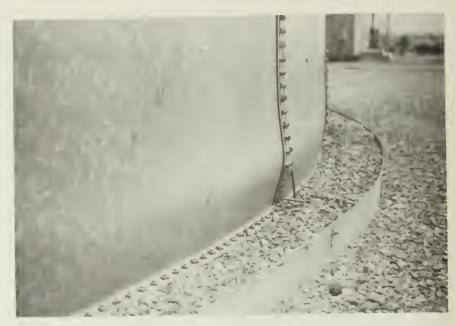
Fig. 6a. Elephant's Foot bulge at the base of a storage tank (Sec 13 - T20S/R14E).

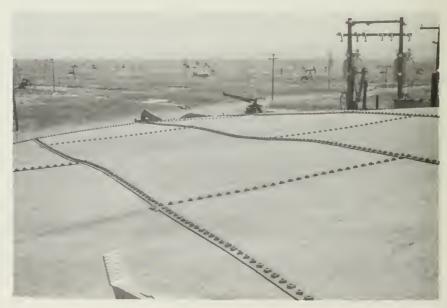
Fig. 8b. Ripples in the top of a storage tank (Sec 13 - T20S/R14E).

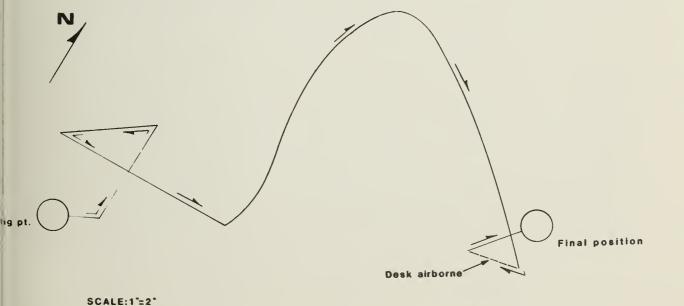
- 8. A large, free-standing desk in the downtown Coalinga office of the California Division of Oil and Gas slid along a newly polished floor, scratching out a trace of its path. Figure 10 is a copy of this trace, which is probably a record of the motion that the building experienced as it slid around under the desk. Note that the net movement of the desk was in an east-northeasterly direction, indicating that the building's net movement was probably toward the west-southwest.

Fig. 10 Sketch of the relative movement of a large, free standing desk in the town of Caalinga during the May 2nd earthquake.

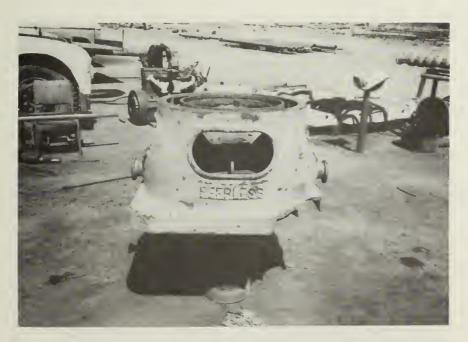
Damaged pump base. Well no. 6.

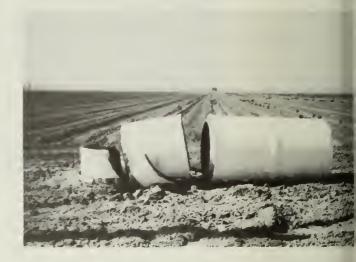
Typical damaged standpipe.

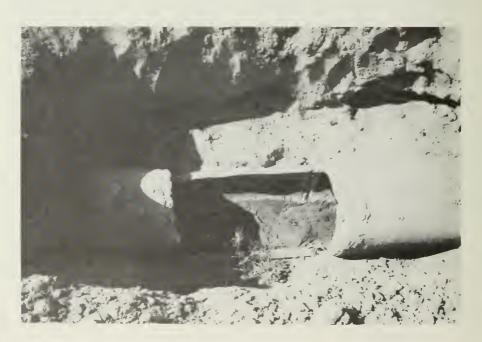
Figure 4. Buried pipeline under operation during earthquake. Damage to top section caused by pressure surges.

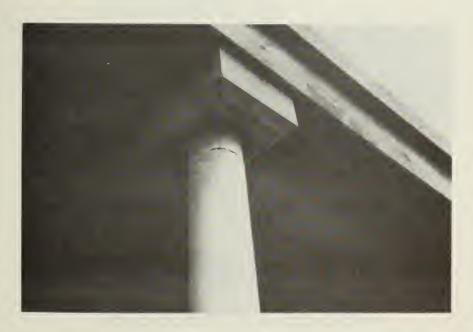
PHOTO 2 Jacalites Creek Bridge, Br. No. 42-072 Top of pile bent looking south.

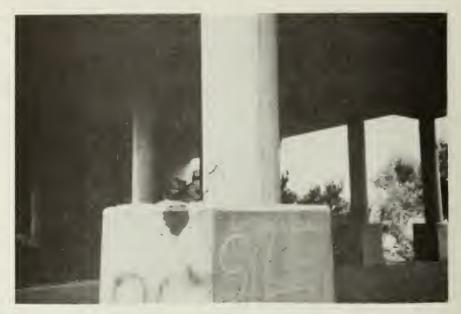
PHOTO 3 Jacalitos Creek Bridge, Br. NO. 42-072 Bottom of pile bent looking south.

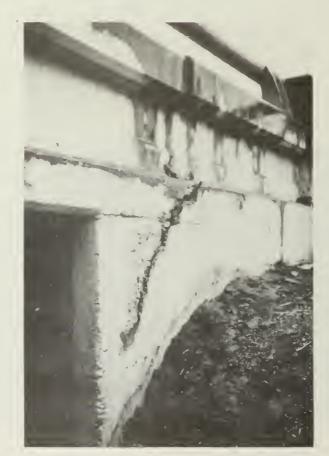
PHOTO 4 Phelps Avenue Overhead, Br. No. 42-233 R/L Abut. 5 Rt. Bridge locking west.

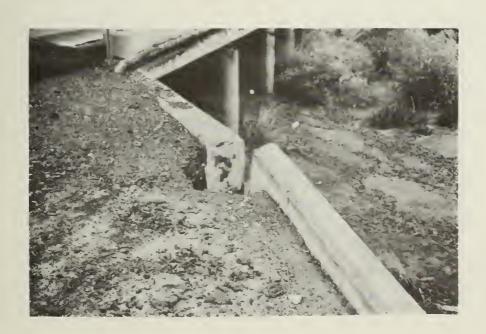
PHOTO 6 Los Gatos Creek Bridge, Br. No. 42-005 South Abut. looking south.

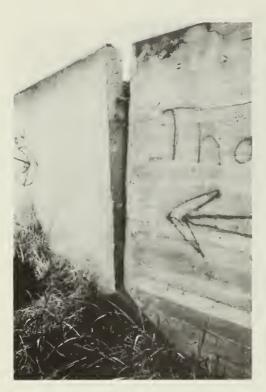
PHOTO 7 Los Gatos Creek Bridge, Br. Ho. 42-005 South Abut. looking down.

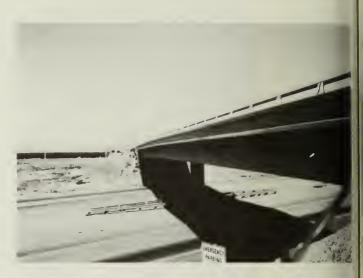
The typical CALTRANS overcrossings on Route I-5 are two span box girder structures on single column bents and end diaphragn abutments (Photo 8). The column transverse reinforcement was largely # 4 hoops at 12" spacing. The undercrossings for the most part are three span slab bridges on pile bents and end diaphragm abutments (Photo 9). These and several other bridges in the area showed signs of movement but no significant structural distress. These types of structures have proved to be able to withstand damaging earthquakes very satisfactorily. The earthquake damage that was evident as a result of this earthquake provided little if any additional information about bridge survival of retrofitted bridges. None of the bridges surveyed had hinges and for the most part the large architectural columns proved to be more than adequate. No bridges in the area have been identified for EQ retrofitting in the statewide program.

PHOTO & Typical Overcrossing over I Two-span bridge with single colubents and end diaphragm abutments.

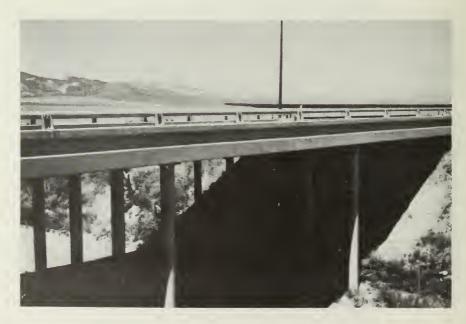
PHOTO 9 Typical Undercrossing on I-5 Three-span slab bridge on pile bents with end diaphragmabutments.

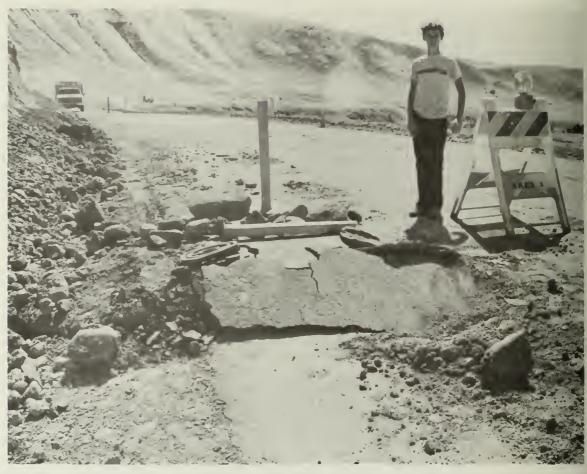
Photo 1. View to east of 15 to 20 cm-high scarp on Nunez fault where it crosses Los Gatos Road, just before road was repaired on June 11, 1983 (locality 12). (Photo courtesy West Hills College, Coalinga.)

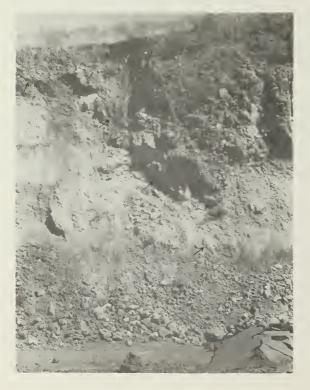
Photo 2. Looking north at Nunez fault in Los Gatos Road cut. Reverse fault of June 10 dips about 65°E, as shown by alignment of scarp in road and cracks in cut (partly covered by debris). Dip of fault flattens upward through soil unit (arrows), emerging as scarp and moletrack features at surface (to left of photo). Fault separates conglomerate and sandstone on right from sheared material. Note that soil thins abruptly to east, suggesting previous recent faulting. Also note tension cracks in bedrock (upper right). (Photo courtesy West Hills College, Coalinga.)

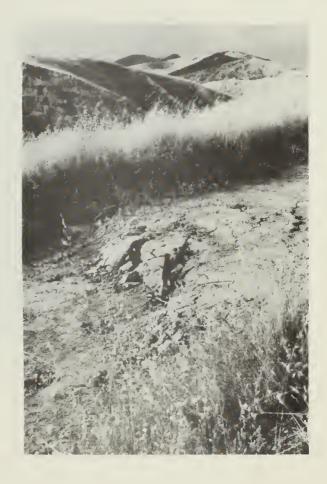
co 3. Looking north at 18 cm-high ressional scarp in dirt road on 14 (locality 1). Feature is cative of east-dipping reverse ut.

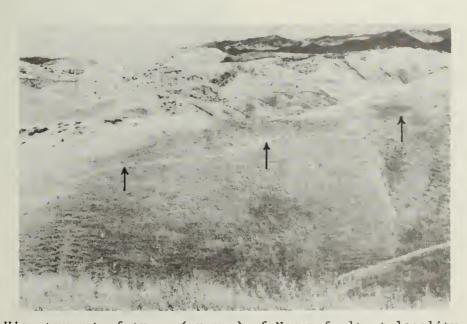
hoto 4. View to west of trace (arrows) of Nunez fault at locality 2. everse movement on fault, which dips steeply toward east, has created idehill bench by previous displacement on east-facing slope. Scarp formed by ecent faulting, ranging from 20 to 30 cm, coincides with bench.

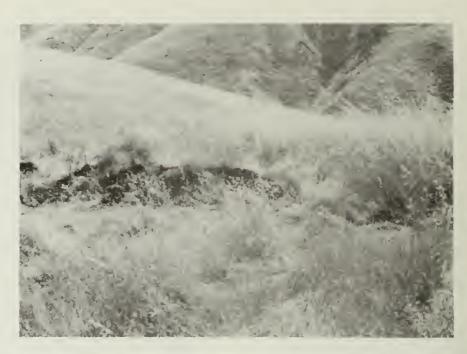
Photo 5. Looking east at 0.5 m-high scarp on ridgecrest at locality 6 on June 15.

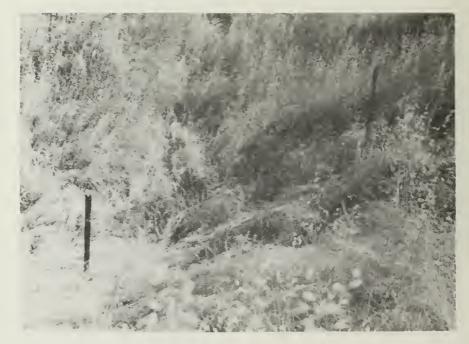
Photo 6. View to south of slackened wire in shortened fence caused by reverse slip on east-dipping Nunez fault, which passes between posts (locality 8).

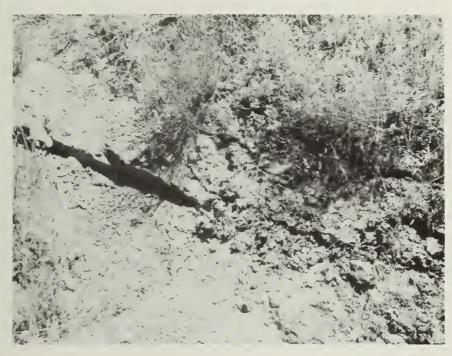
Photo 7. Looking northeast at fresh ruptures formed along Nunez fault on July 21 (locality 16). Scarp and left-stepping cracks indicate oblique slip along steeply east-dipping fault. Fault plane in soil dips steeply east. Photo taken July 23.

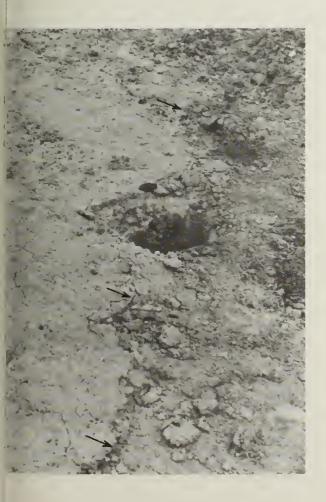
scarplet may have been due to shaking (landslide toe), it was well developed only in bedrock, was not parallel to the slope or road, and did not appear to be associated with nearby downslope fissures that were generally oriented east—west, parallel to the road and ridgeline. Because of these facts and because it is located in steeply dipping beds on the west flank of the Coalinga anticline, we believe that the scarplet may be of tectonic origin.

Photo 8. Looking southeast along southwest-facing scarplet (arrows) in road at locality A (Figure 1). Feature indicates 3 to 4 cm of reverse slip along east-dipping fault, formed during May 2 earthquake. Thrust feature, which aligns with N30°E-dipping bedrock shears exposed in pit, may be tectonic (see text). (Photo by W.A. Bryant, 5/6/83).

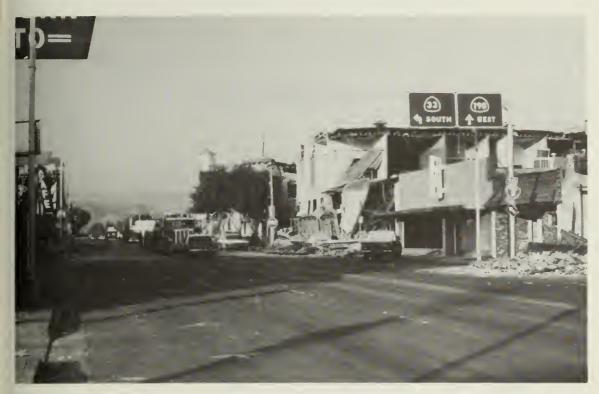
Photo. Damage in downtown Coalinga caused by the 2 May earthquake. Old masonry structures have collapsed or have been severely damaged. A modern single-story frame building (P.G.&E.) is not damaged and the steel water tank (only partly full at the time of the earthquake) remains standing.
